INDOOR AIR QUALITY ASSESSMENT

**Paul Revere Elementary School
395 Revere Street
Revere, Massachusetts**

Prepared by:
Massachusetts Department of Public Health
Bureau of Environmental Health Assessment
June, 2001

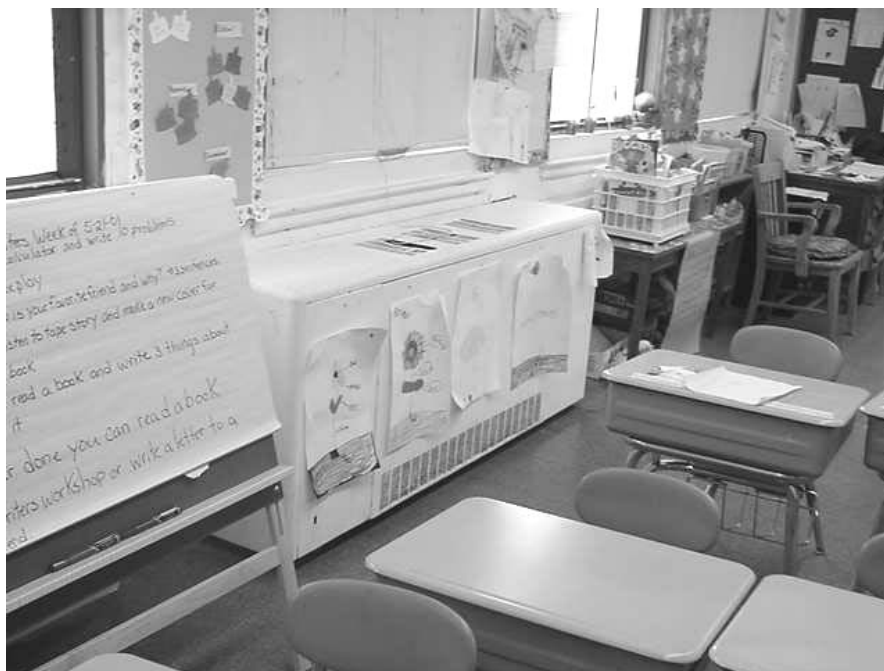
Picture 1

Fresh air in classrooms is supplied by a unit ventilator (univent) system (see Picture 1). Univents draw air from outdoors through a fresh air intake located on the exterior walls of the building (see Picture 2) and return air through an air intake located at the base of each unit ([see Figure 1](#)). Fresh air and return air are mixed, filtered, heated and provided to classrooms through a fresh air diffuser located in the top of the unit. As previously reported by school occupants the univent was deactivated the week prior to the onset of symptoms. Therefore no mechanical means of fresh air was being provided to classroom 102 immediately prior to the relocation. Without dilution by supply ventilation, excess heat and environmental pollutants can build up and lead to indoor air complaints.

Classroom 102 Univent

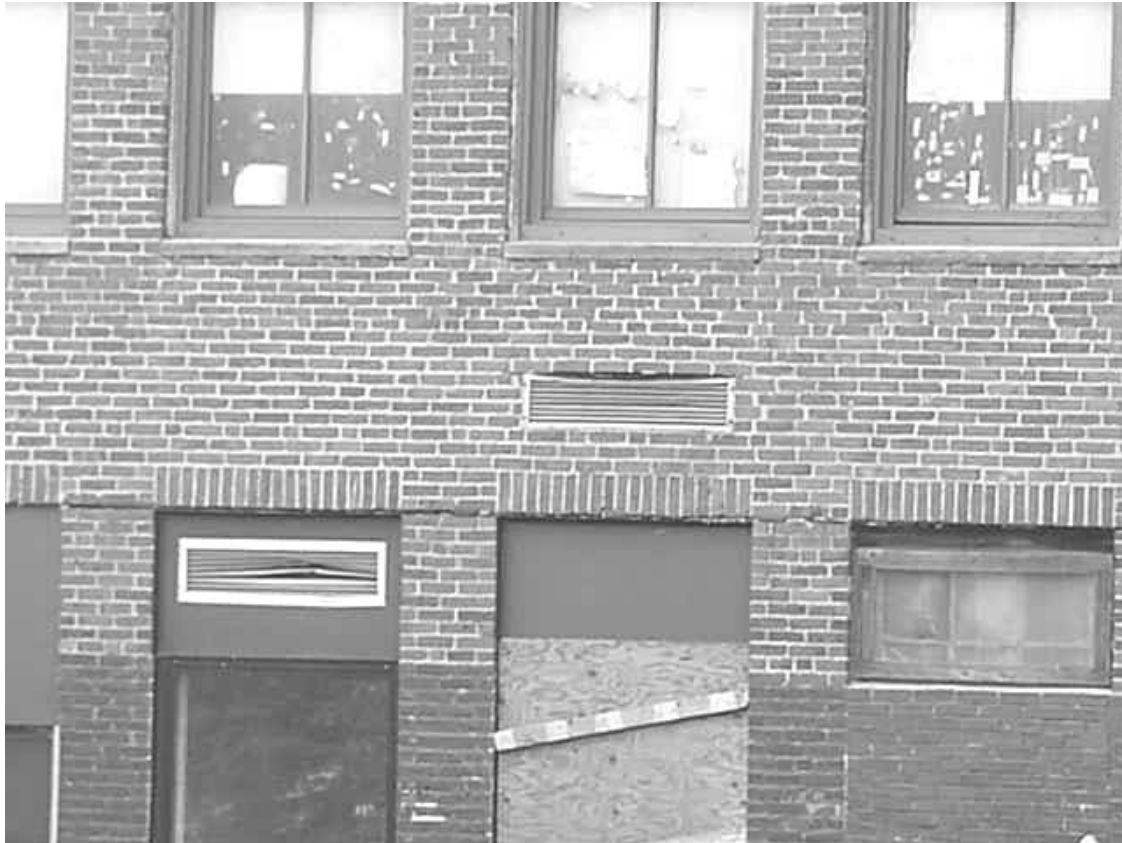
Picture 2

Univent Outside Air Intake for Classroom 102

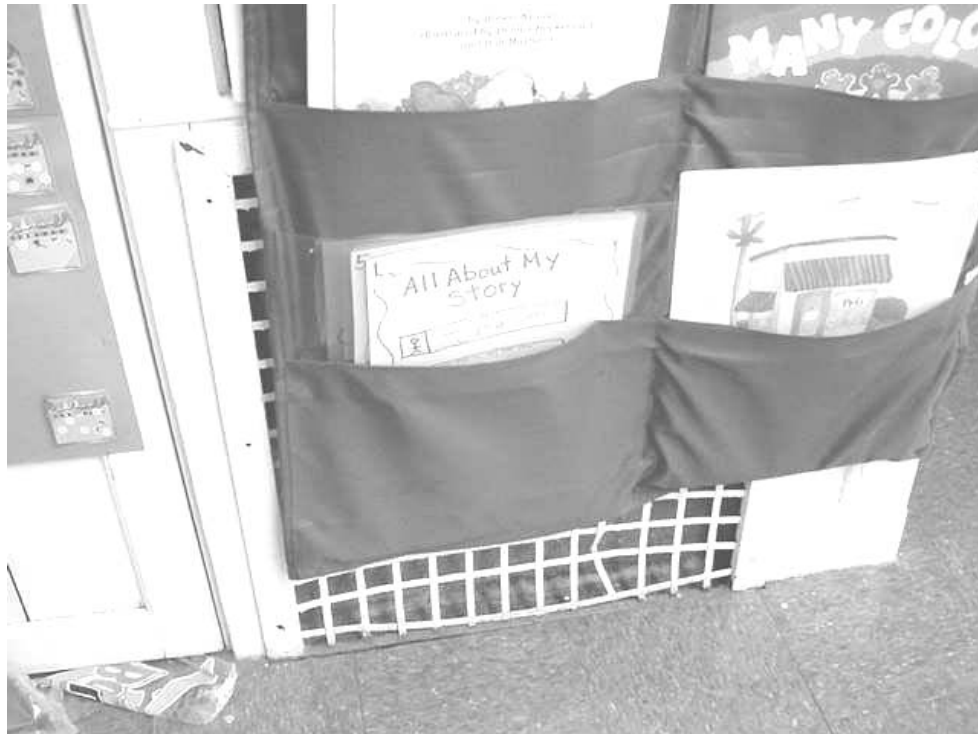
Picture 3

Mechanical exhaust ventilation is provided by wall-mounted intake grills, located at floor level, powered by rooftop motors. Exhaust vents have internal flues that are controlled by pull chains to adjust airflow. The exhaust vent for classroom 102 was functioning at the time of the assessment, however the exhaust grate was partially blocked (see Picture 3) by a hanging book holder.

Classroom Exhaust Vent Note Vent is Obstructed

1. To maximize air exchange, the BEHA recommends that both supply and exhaust ventilation operate continuously during periods of school occupancy independent of classroom thermostat control.
2. Ensure univent fresh air diffuser, return vent and exhaust vent remain free of obstructions to facilitate airflow.
3. For buildings in New England, periods of low relative humidity during the winter are often unavoidable. Therefore, scrupulous cleaning practices should be adopted to minimize common indoor air contaminants whose irritant effects can be enhanced when the relative humidity is low. To control for dusts, a HEPA filter equipped vacuum cleaner in conjunction with wet wiping of all surfaces is

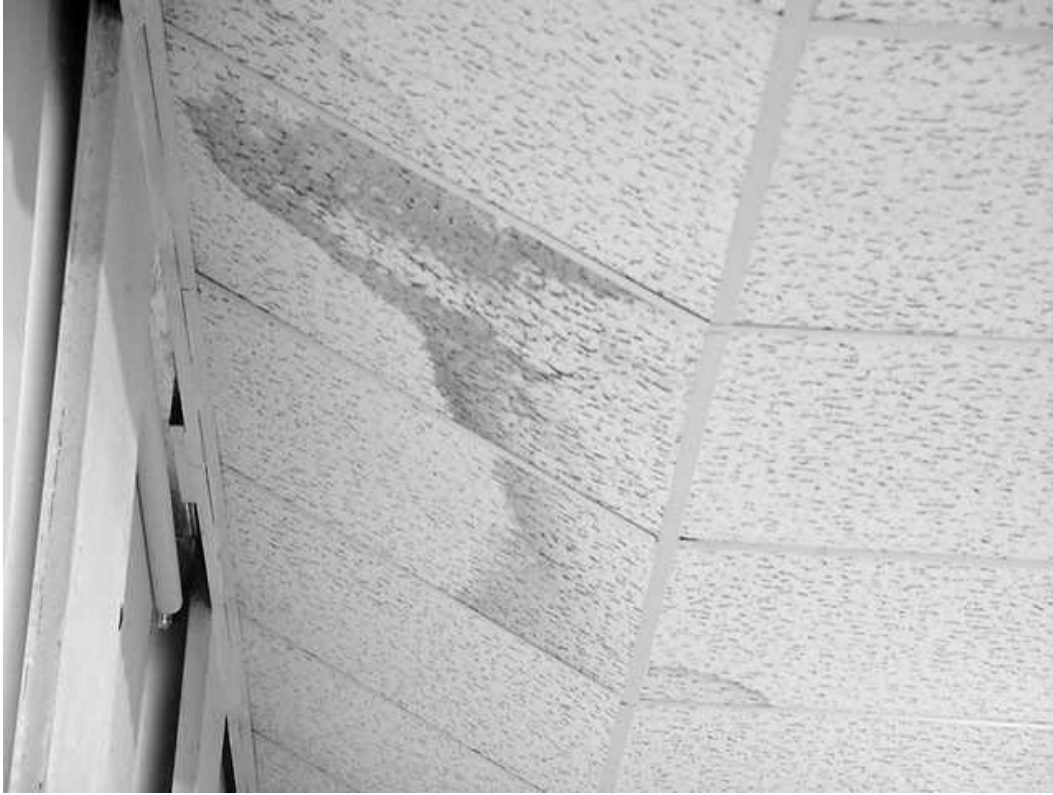
Picture 4

Classroom 102 contained several water-damaged ceiling tiles along the exterior wall, which can indicate historic leaks from either the roof or plumbing system (see Picture 4). Water-damaged ceiling tiles and other porous building materials can provide a source of microbial growth and should be repaired/replaced after a water leak is discovered. The occupant reported no active leaks in the classroom.

Water-Stained Ceiling Tiles
